一起主变本体保护误动事故的分析

徐忠伟,张步涵

摘要:通过分析保护装置内部二极管击穿引起变压器本体保护误动的事故,介绍了分离变压器跳闸和信号回路的改进方法和措施,避免保护误动事故的再次发生。

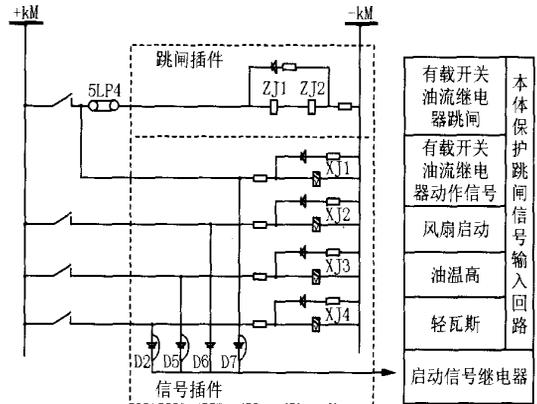
图1 保护装置回路原理图

部动作信号时,可能导致另外一个二极管已击穿的回路误发信号或误动,检查结果证实:信号插件上的二极管D2、D5、D7同时击穿(如图1),造成继电器动作出口误动。继保人员更换了以上3个二极管,经过模拟试验正常后投入主变本体保护。

事故的初步分析和处理后,有关生产技术人员经过分析和讨论,认为主变风扇启动时,信号插件的二极管D6正常导通,导致正电源经反向击穿二极管D7,启动分接开关油流继电器信号回路,再串入有载分接开关油流继电器跳闸回路,导致有载分接开关油流继电器动作重动继电器动作,是装置误动的直接原因。虽然装置每年仅进行一次定检工作,但由于该信号回路没有自检、监视和告警的功能,因而装置本身的设计存在不易被发现的缺陷。

因此,此次事故一方面反映了装置的元件质量可能存在问题,另外一方面也反映了回路设计上也存在一定的缺陷。

2) 针对该装置信号回路没有自检、监视和告警的功能,马上组织人员对运行中同系列的保护装置进行检查,采取临时措施:解除所有本体重瓦斯、有载分接开关油流继电器等跳闸输入回路上并联的信号回路,避免了出现同类问题的可能;

3) 最终确定了反事故措施,即在装置外部加装3个中间继电器,使本体重瓦斯、有载油流继电器、压力释放阀等本体触点分别对应中间继电器,再利用中间继电器的重动触点分别启动装置的跳闸回路和信号回路,即把跳闸、信号回路的输入部分进行电气上的
